Property Inspection Report

LOCATED AT:
10000 Star Dr
Somewhere, Texas 79777

INSPECTED ON:
Tuesday, May 10, 2022

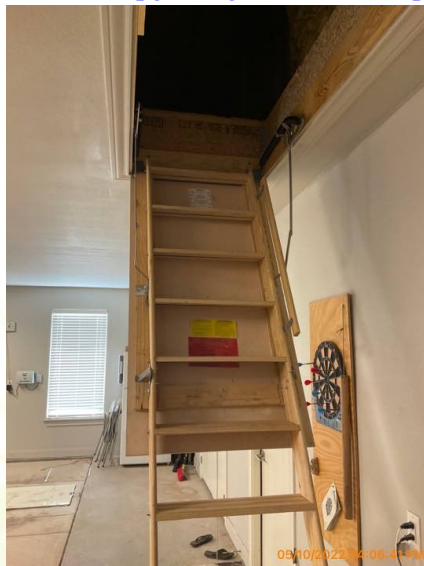
UPG The attic access pull down at the garage was made of thin material which lacks proper fire separation to the attic structure. This is a very common pull down access for our area; however, upgrading to a fire rated pull down would help to improve safety in the home.

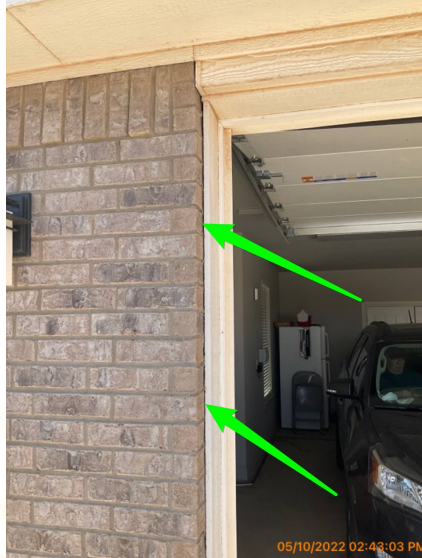
UPG It is recommended to seal any trim at the exterior of the home. This will help prevent premature deterioration at these areas. This can be accomplished by applying a high quality caulking during regular home maintenance.

Areas needing sealed around the garage trim

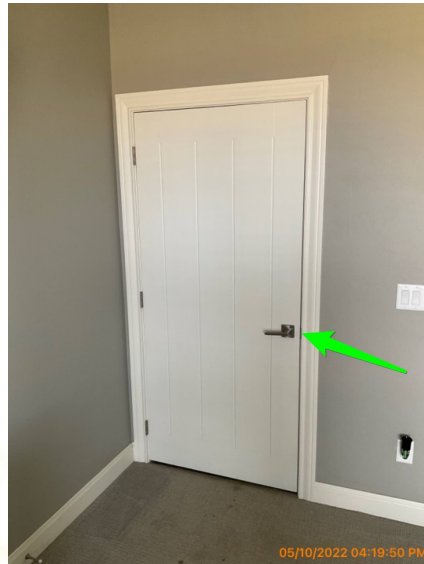
UPG One or more of the doors did not latch properly. Minor adjustments to the hardware or doors are recommended to restore proper function.

The master bedroom door did not latch properly

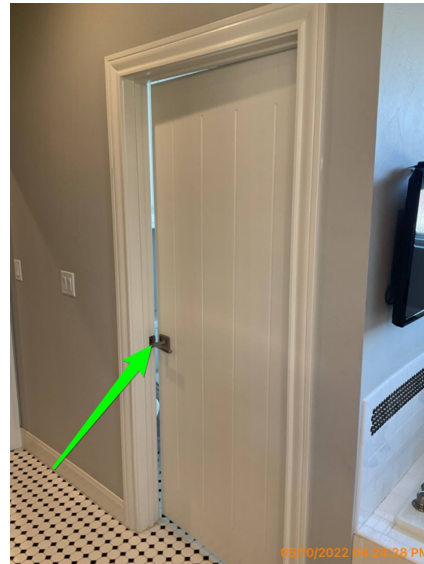
The master bathroom toilet room door did not latch properly

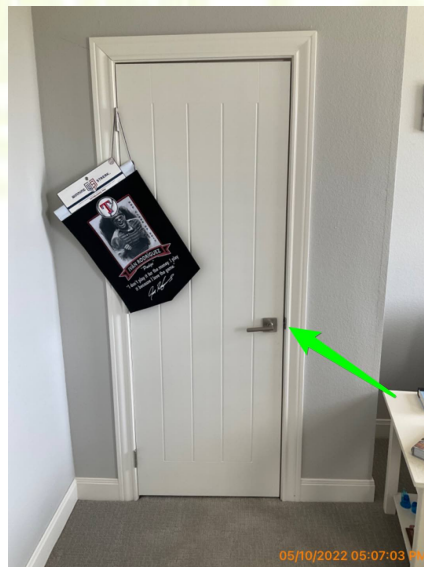
The front right bedroom closet door did not latch properly

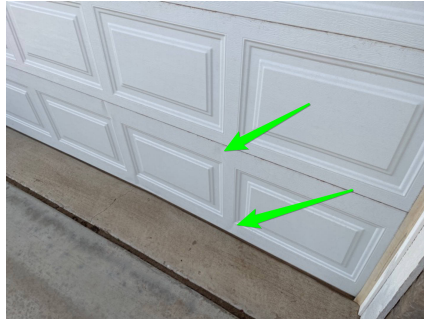
The larger garage door had some slight damage. This was mainly a cosmetic issue only and wasn't hindering the proper operation of the door.

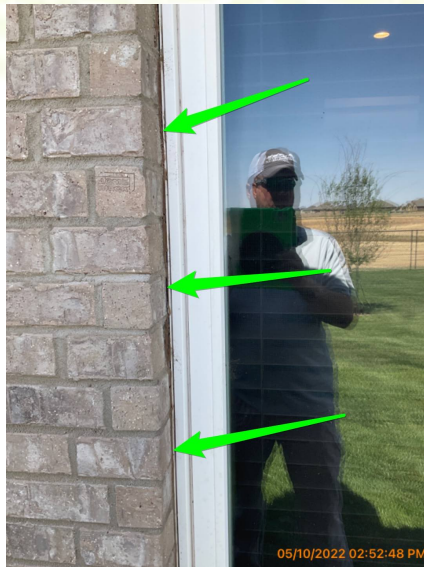
UPG It is recommended to seal around the windows. This will help prevent premature deterioration, pest intrusion, and help to maintain energy efficiency. This can be accomplished by applying a high quality sealant. Caution: Any weep holes at the bottom of windows should never be sealed or covered up.

Areas needing re-sealed around some of the windows

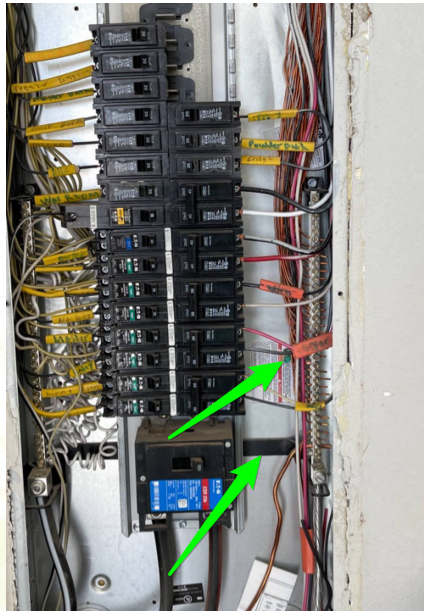
The remote distribution panel located in the garage was bonded at the neutral bus bar and the bus bar was not isolated. The neutrals at the first means of disconnect (service panel) should be bonded and the neutrals at distribution panels should be isolated. This can be a safety issue due to the potential failure of the grounding system. It is recommended to have a licensed electrical contractor evaluate the panel and make repairs as needed.

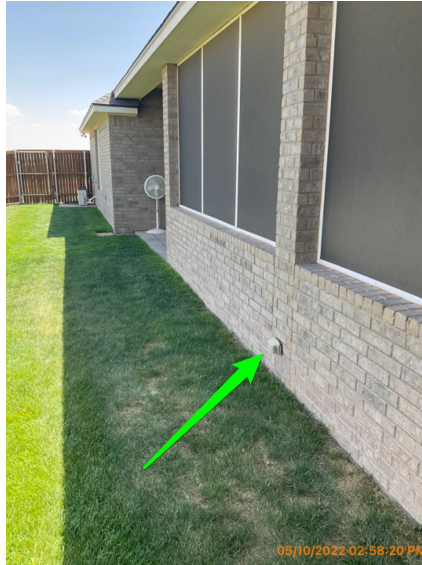
There were one or more GFCI receptacles that did not trip when tested with the "test" button. It is recommended to have a licensed electrician repair as needed for improved safety.

The rear exterior GFCI would not trip

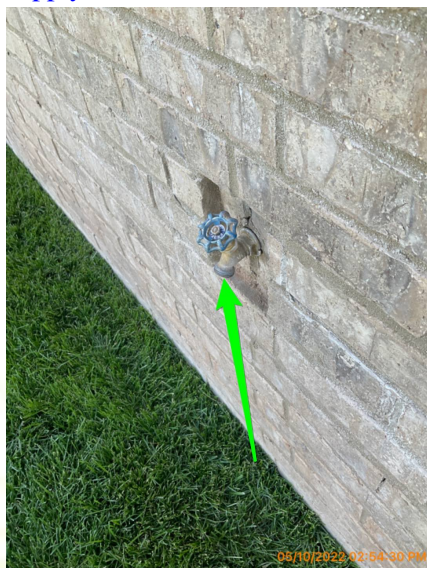
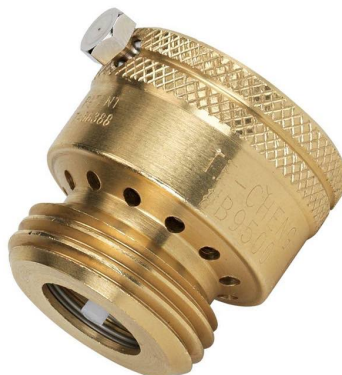
UPG The exterior hose bibbs lacked anti siphon devices at at least one location. These are relatively easy to install, can be found at any local hardware store, and are not costly. It is recommended to add these to prevent the back flow of contaminated water into the water supply.

Missing anti siphon device at the rear exterior hose bibb

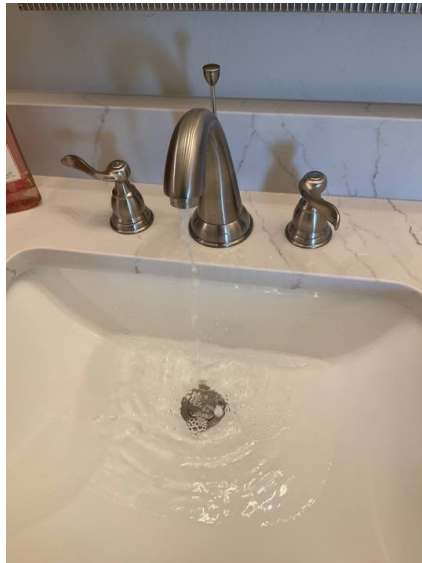
UPG The aerator in the spout at the shared bathroom sink was clogged. For a smoother flow of water with less splashing, all aerators should be cleaned periodically.

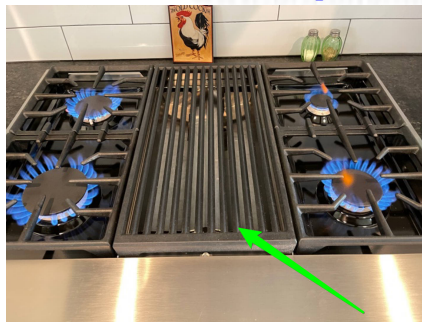
UPG The stove was turned on with the normal operating controls and found to be not fully functional. The grill burner ignition was not operating at the time of inspection. It is recommended to have a reputable appliance technician repair as needed.

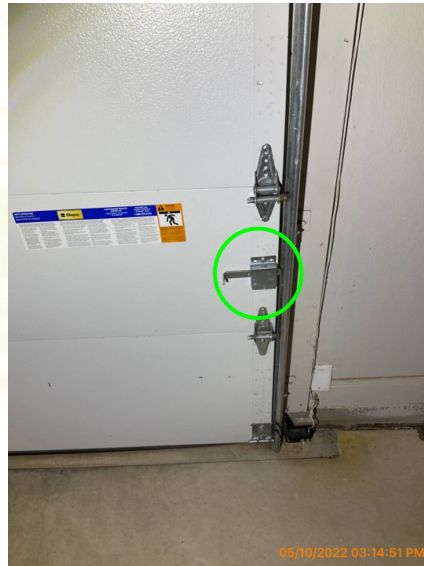
UPG The locking mechanism for the garage door was still present. It is recommended to remove these locks to prevent damage to the door and door opener if the opener is inadvertently operated with the locks engaged. Removal of these locks is a very simple procedure and can be accomplished during regular home maintenance.

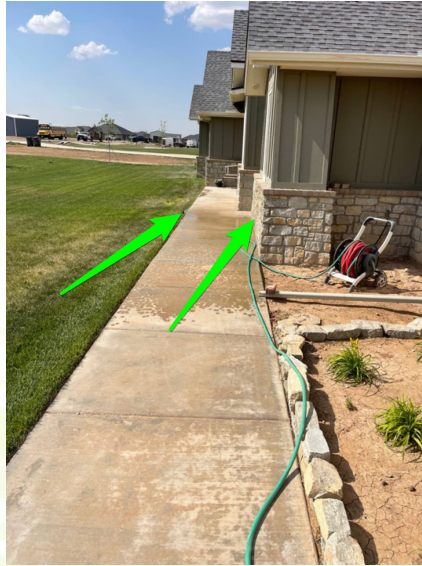
UPG One or more of the sprinkler heads were in need of adjustments. This will help to prevent the unnecessary wasting of water, help to ensure better coverage for heads that are too low, and help prevent premature deterioration of the mortar at the exterior brick veneer for any that are hitting the exterior walls. It is recommended to have a reputable sprinkler technician evaluate the system and make repairs as needed.

Head spraying against the wall at the front

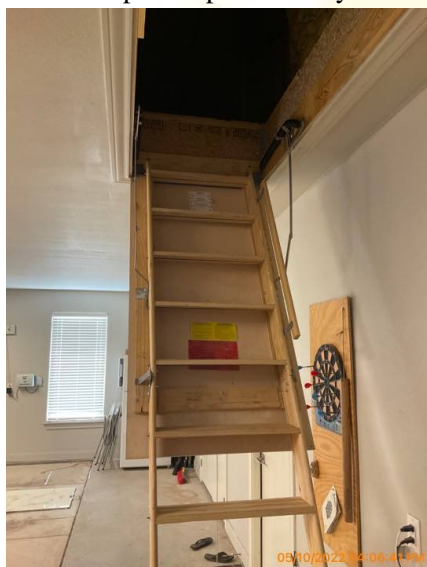
UPG 1: The attic access pull down at the garage was made of thin material which lacks proper fire separation to the attic structure. This is a very common pull down access for our area; however, upgrading to a fire rated pull down would help to improve safety in the home.

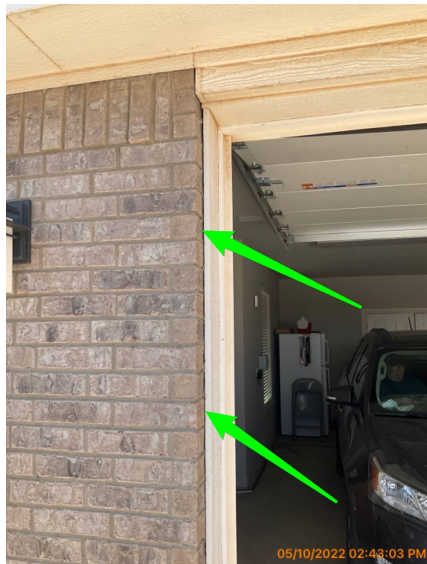
UPG 2: It is recommended to seal any trim at the exterior of the home. This will help prevent premature deterioration at these areas. This can be accomplished by applying a high quality caulking during regular home maintenance.

Areas needing sealed around the garage trim

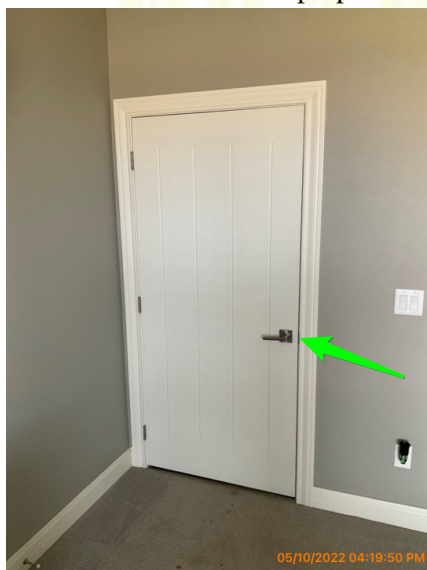
UPG 3: One or more of the doors did not latch properly. Minor adjustments to the hardware or doors are recommended to restore proper function.

The master bedroom door did not latch properly

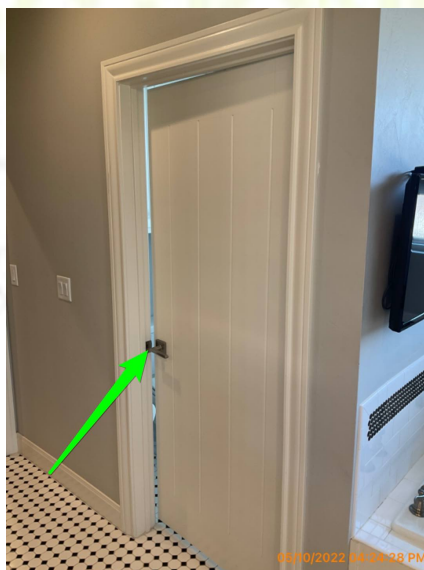
The master bathroom toilet room door did not latch properly

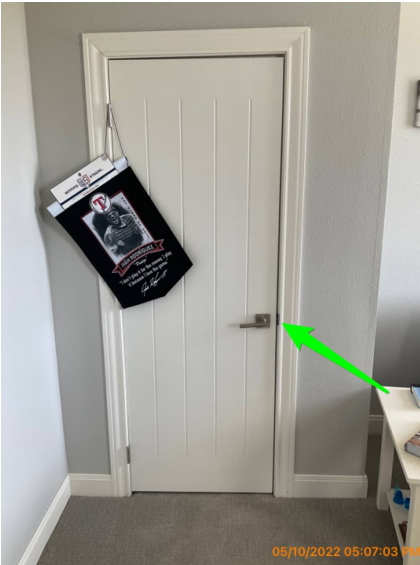
The front right bedroom closet door did not latch properly

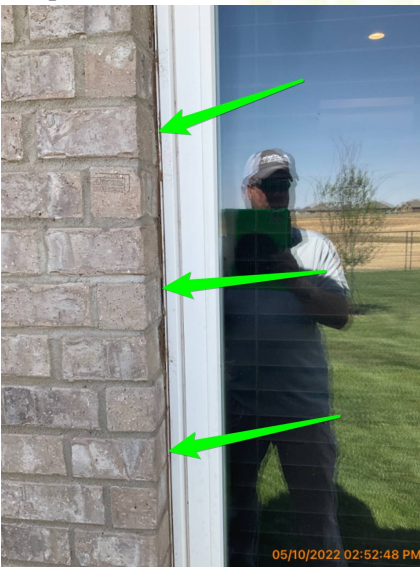
UPG 4: It is recommended to seal around the windows. This will help prevent premature deterioration, pest intrusion, and help to maintain energy efficiency. This can be accomplished by applying a high quality sealant. Caution: Any weep holes at the bottom of windows should never be sealed or covered up.

Areas needing re-sealed around some of the windows

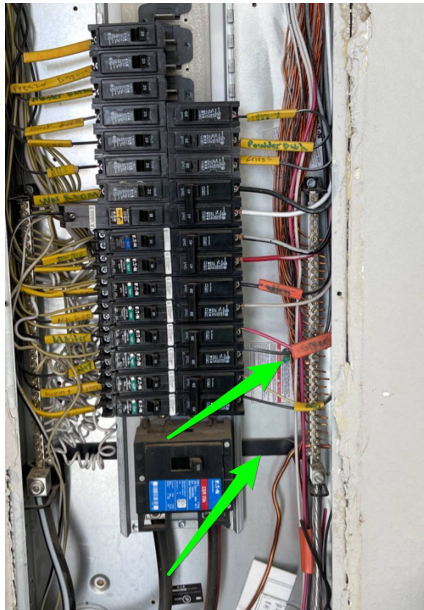
WARN 5: The remote distribution panel located in the garage was bonded at the neutral bus bar and the bus bar was not isolated. The neutrals at the first means of disconnect (service panel) should be bonded and the neutrals at distribution panels should be isolated. This can be a safety issue due to the potential failure of the grounding system. It is recommended to have a licensed electrical contractor evaluate the panel and make repairs as needed.

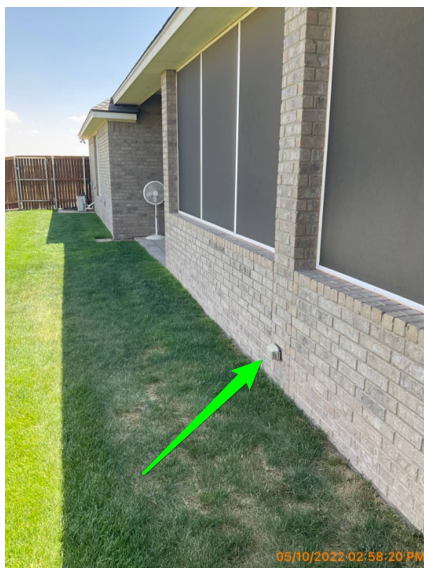
WARN 6: There were one or more GFCI receptacles that did not trip when tested with the "test" button. It is recommended to have a licensed electrician repair as needed for improved safety.

The rear exterior GFCI would not trip

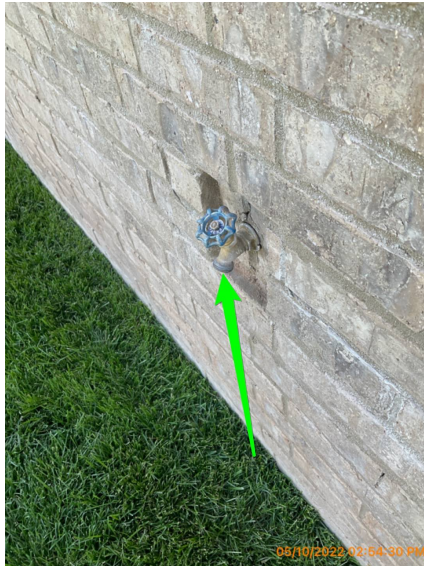
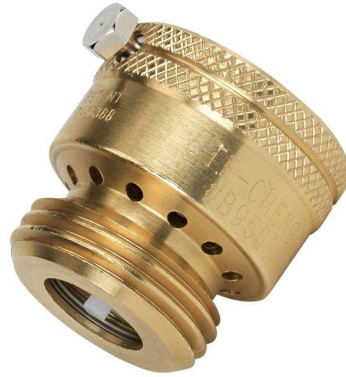
UPG 8: The exterior hose bibbs lacked anti siphon devices at at least one location. These are relatively easy to install, can be found at any local hardware store, and are not costly. It is recommended to add these to prevent the back flow of contaminated water into the water supply.

Missing anti siphon device at the rear exterior hose bibb

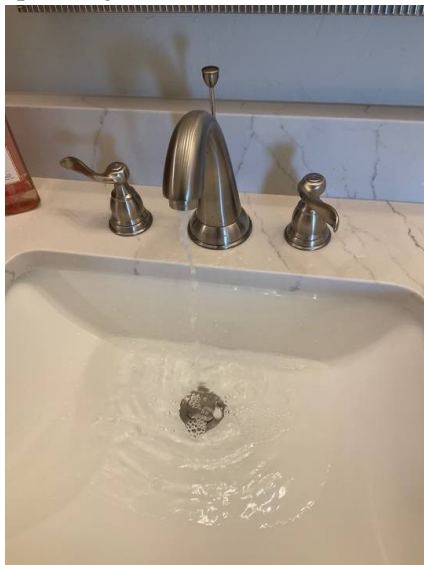
UPG 9: The aerator in the spout at the shared bathroom sink was clogged. For a smoother flow of water with less splashing, all aerators should be cleaned periodically.

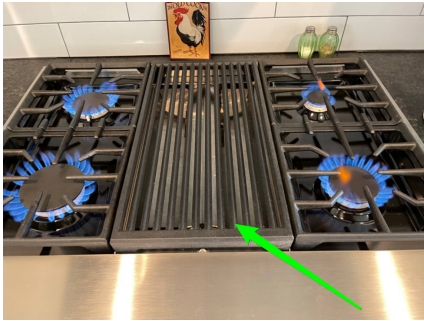
UPG 10: The stove was turned on with the normal operating controls and found to be not fully functional. The grill burner ignition was not operating at the time of inspection. It is recommended to have a reputable appliance technician repair as needed.

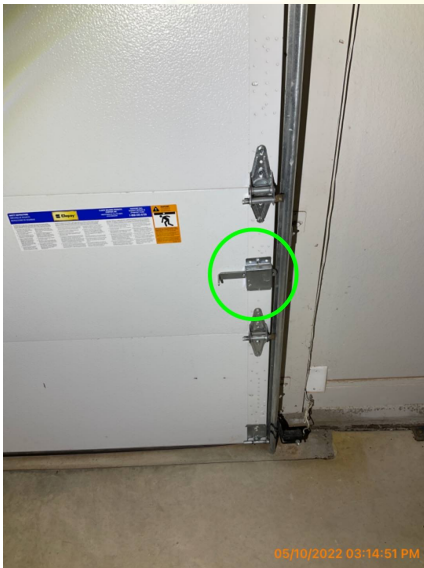
UPG 11: The locking mechanism for the garage door was still present. It is recommended to remove these locks to prevent damage to the door and door opener if the opener is inadvertently operated with the locks engaged. Removal of these locks is a very simple procedure and can be accomplished during regular home maintenance.

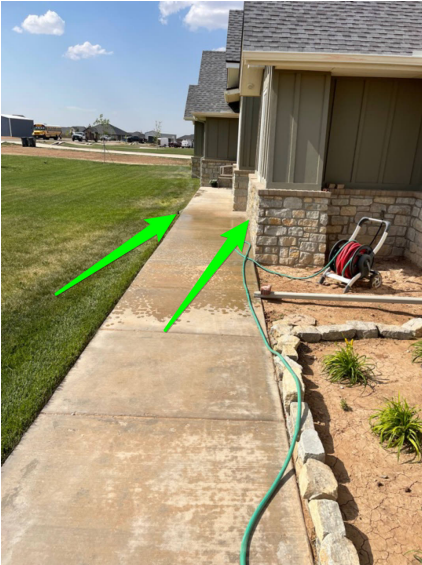
13: One or more of the sprinkler heads were in need of adjustments. This will help to prevent the unnecessary wasting of water, help to ensure better coverage for heads that are too low, and help prevent premature deterioration of the mortar at the exterior brick veneer for any that are hitting the exterior walls. It is recommended to have a reputable sprinkler technician evaluate the system and make repairs as needed.

Head spraying against the wall at the front
